# IMPACTS OF THE 14<sup>TH</sup> NOVEMBER 2016 KAIKŌURA EARTHQUAKE ON THREE WATERS SYSTEMS IN WELLINGTON, MARLBOROUGH AND KAIKŌURA, NEW ZEALAND: PRELIMINARY OBSERVATIONS

## ABSTRACT

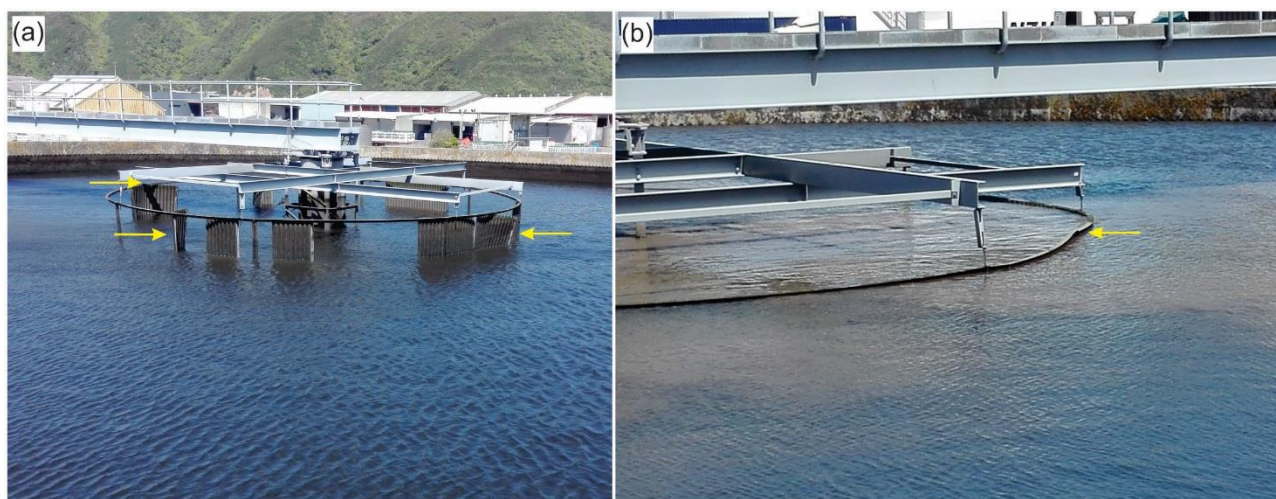
The four wastewater treatment plants in Wellington region are. Moa Point (Wellington), Seaview (Upper Hutt and Lower Hutt; see Figure 1a for location), Porirua and Western (Karori). In the Seaview and Porirua treatment plants, water seicheing in the secondary clarifier tanks damaged the stilling well curtains and their holding rings that baffle mixed liquor influent to aid settling (Figure 2).

**Figure 2. Damage at the Seaview Waste Treatment Plant. See Figure 1a for location. (a) Displaced curtain panels in the stilling well in one of the Seaview treatment plant clarifiers. (b) Damaged ring that holds the curtains of the stilling well in one of the Seaview treatment plant clarifiers (Photos: Hutt Valley Water Services Ltd).**

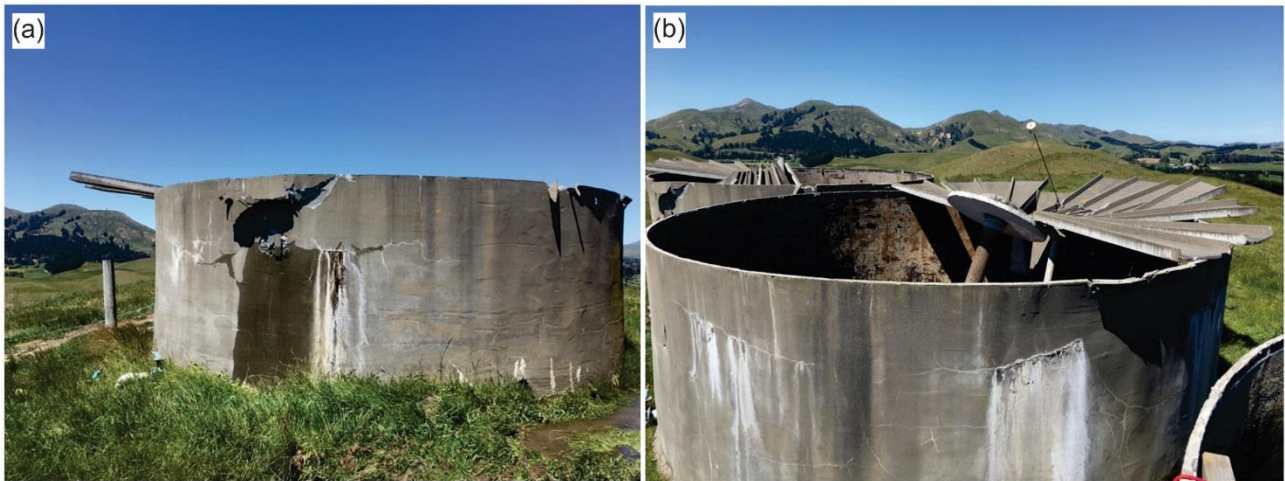
**Figure 6.** Ferrocement tanks at Ward, installed in the 1950s. (a) The thin ferrocement walls have failed and the segmented roof has collapsed (Photo: Marlborough District Council). (b) The segmented roof and the central pillar have collapsed (Photo: Marlborough District Council).

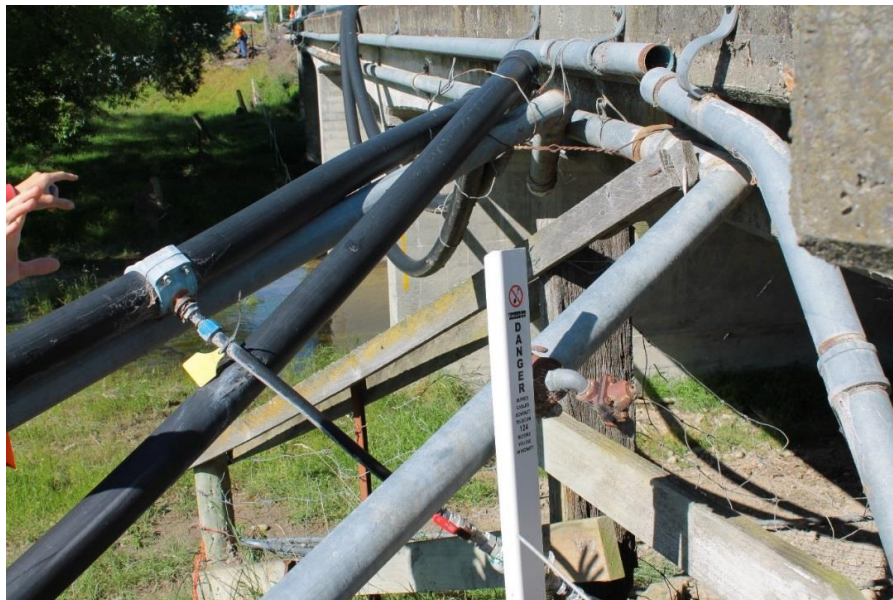
In addition to the Elizabeth Street footbridge in Blenheim, damage occurred at several other pipe service bridges across the region. For example, pipelines between relatively rigid bridge abutments and the ground were damaged as observed at the Needles Creek bridge site along State Highway 1, north of

**Figure 7.** East side of the Needles Creek Bridge north of Ward on the SH1, viewed from the north. Original freshwater pipelines have failed and been replaced temporarily with ductile pipes (in black) (Photo: X. Bellagamba).

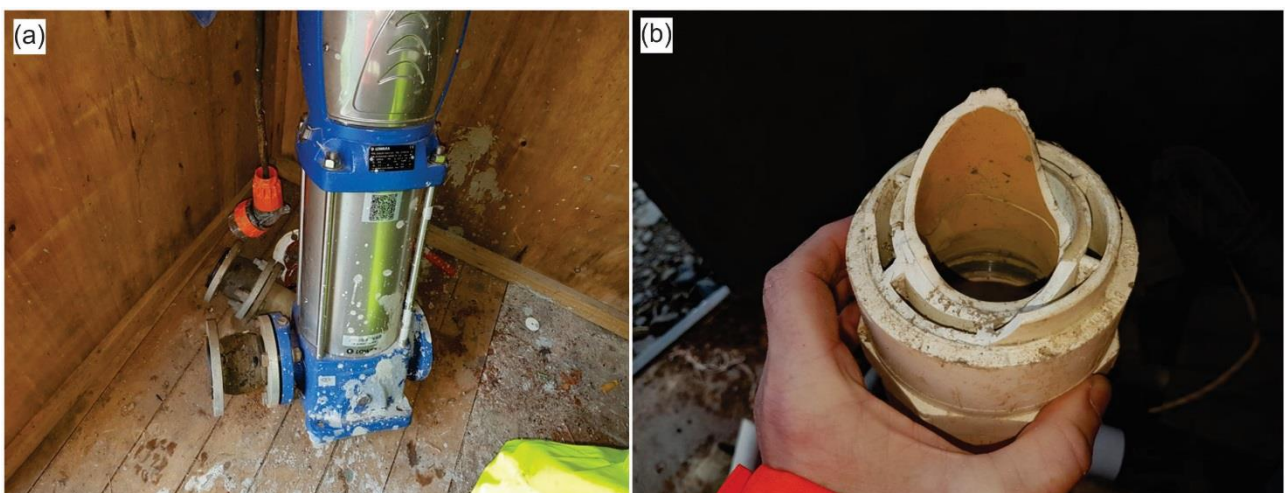
Ward (Figure 7). Observed damage where pipes connect to bridges and other structures suggest more flexibility of the pipeline system would be important. A water supply well pump in Ward failed when movement of the water supply well relative to the nearby pump house resulted in the hold down bolts pulling out of the concrete base and displacement of the pump despite the presence of a rubber bellows joint. While this had caused an outage, it was believed that this had prevented failure of the pump itself (Figure 8).

**Figure 8.** (a) Grundfoss pump in pump house at Ward. When the water supply well was displaced, the galvanized steel pipework pulled on the pump. The bolts holding the pump to the concrete slab then failed, causing the pump to topple. (b) Failed PVC pipework from the Taimate water supply well near Ward. The pump house building slid on its base, causing the water supply well pipework to fail.

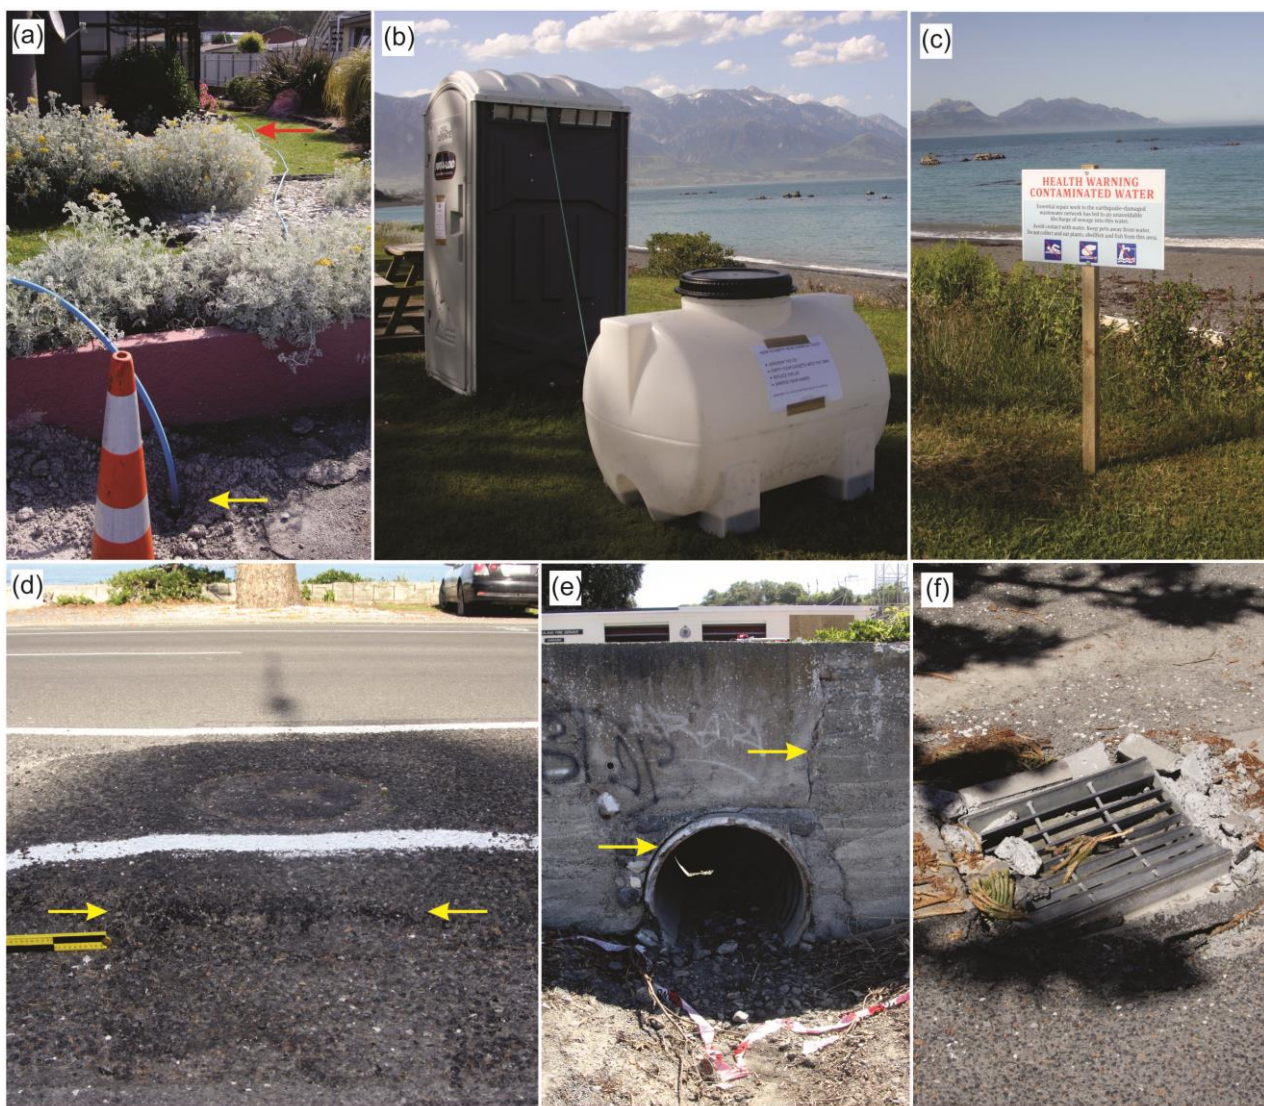
The Kaikōura supply system is a combination of water supply wells and hilltop reservoirs, which feed a reticulated supply to Kaikōura township and surrounding suburbs. The 14<sup>th</sup> November 2016 event shut down all power to the system, and in combination with severe damage to buried services the reticulated supply reduced to zero. At the time of the event one reservoir was full, but would have lasted only one day at normal demand (I. Walker, pers. comm.). Kaikōura District Council (KDC) initiated a rapid programme of assessment and repairs, and by 15<sup>th</sup> November was able to inform residents which streets had supply. Residents without supply were encouraged to approach others on streets that had supply to access water. By 19<sup>th</sup> November, water stations had been set up at various locations around the township by the New Zealand Defence Force, as well as a mobile public shower unit. Due to system supply shortages, residents were instructed to not use showers in their homes, and to minimise all other water use. By 25<sup>th</sup> November supply had been sufficiently restored in the township to enable use of flush toilets and showers, although the community was asked to shower only every second day, and to not use washing machines or dishwashers. This reflected the fragility of the restored supply, as well as the inability of the waste water system to receive residential grey water (see below). Residents were also instructed to not water their gardens. By the beginning of December supply had been restored to the Kincaid area north of Kaikōura township, but ongoing system leaks did require restrictions to be reinstituted until repairs could be completed; water was distributed in tankers to these residents, and by 4<sup>th</sup> December reticulated supply had been reinstated. Full supply was restored to the Kincaid and Fernleigh water schemes by 9<sup>th</sup> December. Throughout the period 14<sup>th</sup> November to 22<sup>nd</sup> December a boil water notice was placed on all reticulated supply, and public water conservation messages were broadcast. These restrictions were lifted for most of Kaikōura township, suburbs and outlying supply schemes on 23<sup>rd</sup> December, due to system repairs and use of chlorination, although some individual households were required to continue boiling water before use. People returning to houses unoccupied since 14<sup>th</sup> November were urged to run water for 10 minutes and flush toilets, and conduct inspections of pipes and tanks on their properties. For damaged pipes on residential properties, owners were required to attend to these issues on their own initiative, sometime using temporary overlanding of supply (Figure 9a).

Wastewater pipes experienced significant damage, compromising most of the system that is reticulated to the treatment plant north of Kaikōura township. As a result residents were advised to use available portaloos already present in Kaikōura, or to use buckets or holes dug in gardens to dispose of human waste. On November 18<sup>th</sup> chemical toilets were delivered by the New Zealand Defence Force to be distributed to all households in Kaikōura, although the necessary supply of chemical solution for them was delayed by 2-3 days. Residents were informed of chemical toilet dump station locations (Figure 9b). Portaloos were also distributed

**Figure 9. Three waters impacts along The Esplanade, Kaikōura. (a) Temporary overlanding of domestic water supply from the street connection (yellow arrow) to the house's kitchen area (red arrow). (b) Portaloos (left) and chemical toilet dump station (right). (c) Contaminated water warning, discouraging swimming, fishing and shellfish collection. (d) Differential manhole movement of ~3 cm (arrows). (e) Cracking in retaining wall (arrows) surrounding stormwater culvert. (f) Damaged concrete gutter due to impact by steel stormwater grate. (Photos: M.W. Hughes).**

There was little physical manifestation of system damage along roadways, although at least one manhole was noted to have experienced slight differential movement through the 14<sup>th</sup> November event (Figure 9d). Pipe condition assessments via CCTV were occurring from the days after the event, supported by experience and expertise gained from condition assessments conducted in Christchurch through the 2010-2011 CES [21].
